**Flood Control Project Maintenance  
Levee Inspections**

## Maintenance Issue Types Only, Levee Inspection Report By Mile - Spring 2017

### Reclamation District No. 2103 Wheatland Vicinity

Waterway	Bank	Unit Miles	Inspection Start/End	Inspector
Unit No. 01 South Dry Creek	Left	4.64	04/27/2017 04/27/2017	Sterling York

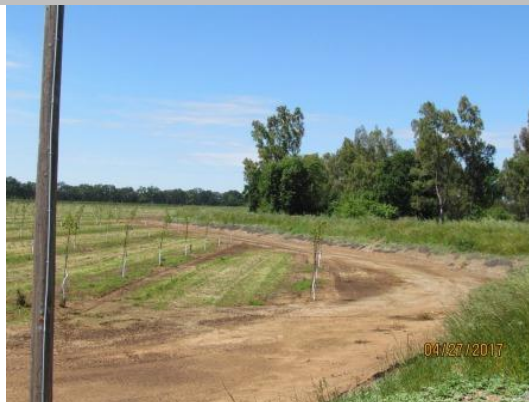
Photo 1 of 1 : SP\_2017\_RD2103\_10\_24\_20170428\_00044.jpg

LM Start	0.01	Rating **	U	Issue No.	24
LM End	1.86	Issue Type +	Ma	Location *	LS
Category	Earthen Levee			GPS Latitude/Longitude	
				Start	End
Item	Vegetation			39.019839 °	39.029682 °
				-121.453890 °	-121.423938 °
DWR ID	DWR_RD2103_01_s_2017_24				
Comment Code					
V1 : Control annual grass and weeds on the levee slopes and easements.					
Inspector Comment					
Annual vegetation needs to be maintained, Spring 2017.

View looking downstream of annual vegetation that needs to be maintained, Spring 2017.

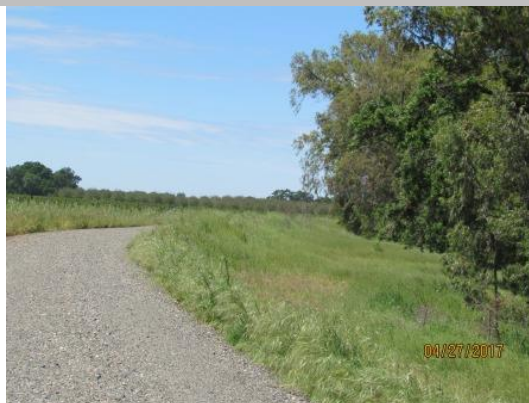
Photo 1 of 1 : SP\_2017\_RD2103\_10\_25\_20170428\_00043.jpg

LM Start	0.01	Rating **	U	Issue No.	25
LM End	1.86	Issue Type +	Ma	Location *	WS
Category	Earthen Levee			GPS Latitude/Longitude	
				Start	End
Item	Vegetation			39.019839 °	39.029682 °
				-121.453890 °	-121.423938 °
DWR ID	DWR_RD2103_01_s_2017_25				
Comment Code					
V1 : Control annual grass and weeds on the levee slopes and easements.					
Inspector Comment					
Annual vegetation needs to be maintained, Spring 2017.

View looking downstream of annual vegetation that needs to be maintained, Spring 2017.

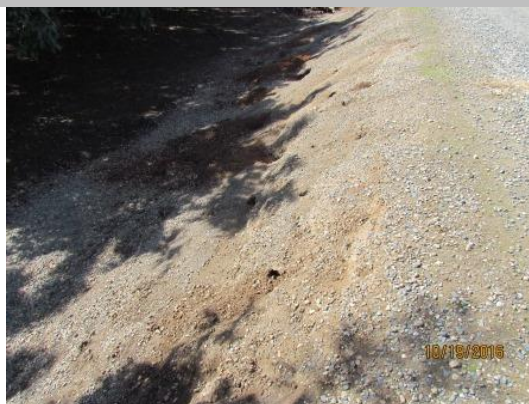
Photo 1 of 1 : SP\_2017\_RD2103\_10\_23\_20170316\_00007.jpg

LM Start	0.20	Rating **	M	Issue No.	23
LM End	0.22	Issue Type +	Ma	Location *	LS
Category	Earthen Levee			GPS Latitude/Longitude	
				Start	End
Item	Animal Control			39.020856 °	39.020938 °
				-121.450629 °	-121.450237 °
DWR ID	DWR_RD2103_01_f_2015_23				
Comment Code					
A3 : No rodents visible, but rodent burrows visible; need to backfill and compact or grout burrows.					
Inspector Comment					
No animal activity observed, Spring 2017.

View of squirrel holes on the waterside looking downstream. Fall 2016.

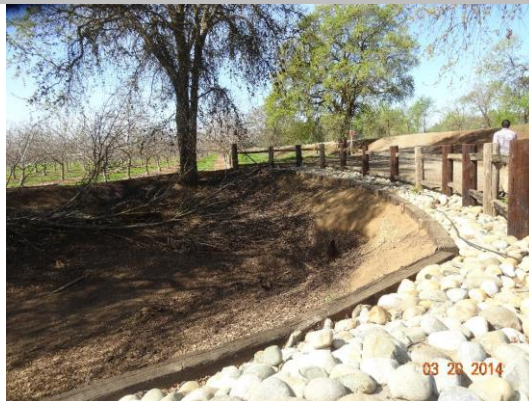
Photo 1 of 3 : UCIP\_SP\_2017\_38325\_69869.jpg

LM Start	0.82	Rating **	A/W	Issue No.	36
LM End	0.82	Issue Type +	Ma	Location *	LS
Category	Supplemental			GPS Latitude/Longitude	
				Start	End
Item	DWR UCIP LMA Responsibility			39.024811 °	39.024811 °
				-121.440750 °	-121.440750 °
DWR ID					
Comment Code					
Inspector Comment					
FS_ID:38325					
DS_ID:19471					
EP_NO: N/A					
Repair Type: No Action Needed					
Crossing Status: Found					
UCIP Comments:					
FIELD_STRUCT_DESC: 36-inch CM drainpipe through the levee, 14.4 feet below the crown. Concrete headwall, flap-gate and 3x6-foot concrete splash apron at waterward toe. Outfall drain from old Grasshopper Slough. (USACE-1962). This entry matches the Drainage or Irrigation Structure referenced in O&M manual (HLM 0.83).					
FS Date: 3/20/2014

View of CMP crossing located on landward side.

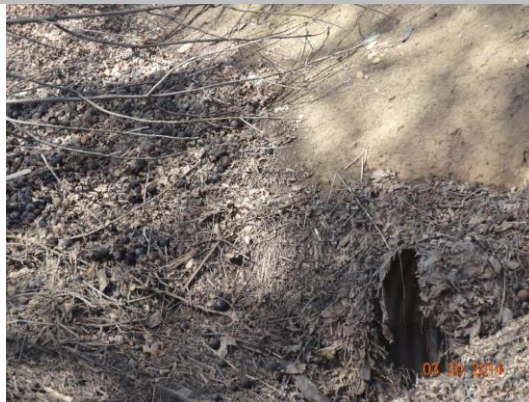
Photo 2 of 3 : UCIP\_SP\_2017\_38325\_69868.jpg

Close up view of crossing from landward side.

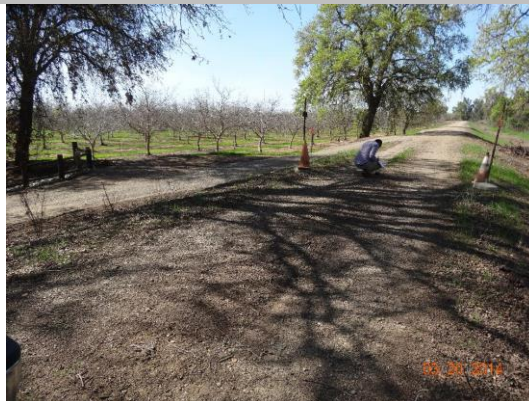
Photo 3 of 3 : UCIP\_SP\_2017\_38325\_69873.jpg

LM Start	0.82	Rating **	A/W	Issue No.	36 (cont)	
LM End	0.82	Issue Type +	Ma	Location *	LS	
Category	Supplemental			GPS Latitude/Longitude		
				Start	End	
Item	DWR UCIP LMA Responsibility			39.024811 °	39.024811 °	
				-121.440750 °	-121.440750 °	
DWR ID						
Comment Code						
Inspector Comment						
FS_ID:38325						
DS_ID:19471						
EP_NO: N/A						
Repair Type: No Action Needed						
Crossing Status: Found						
UCIP Comments:						
FIELD_STRUCT_DESC: 36-inch CM drainpipe through the levee, 14.4						
feet below the crown. Concrete headwall, flap-gate and 3x6-foot						
concrete splash apron at waterward toe. Outfall drain from old						
Grasshopper Slough. (USACE-1962). This entry matches the Drainage						
or Irrigation Structure referenced in O&M manual (HLM 0.83).						
FS Date: 3/20/2014

View of levee crown at crossing.

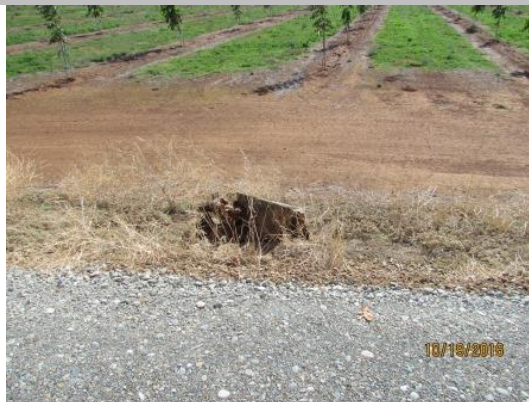
Photo 1 of 1 : SP\_2017\_RD2103\_10\_26\_20170316\_00008.jpg

LM Start	1.27	Rating **	N	Issue No.	26
LM End	1.27	Issue Type +	Ma	Location *	LS
Category	Earthen Levee			GPS Latitude/Longitude	
				Start	End
Item	Trim / Thin Trees			39.027261 °	39.027261 °
				-121.433269 °	-121.433269 °
DWR ID	DWR_RD2103_01_s_2016_26				
Comment Code					
T5 : Tree stumps.					
Inspector Comment					
Stump needs to be removed fom slope. Fall 2016.

View of tree stump on landside levee slope. Fall 2016.

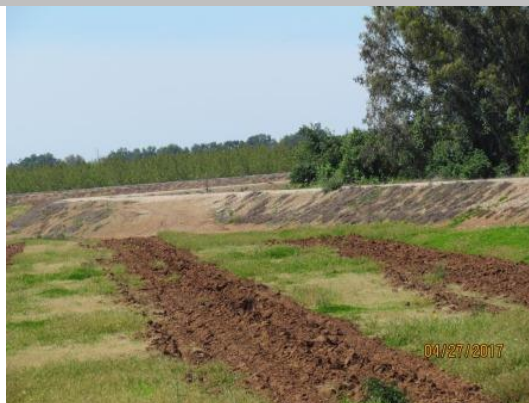
Photo 1 of 1 : SP\_2017\_RD2103\_10\_19\_20170428\_00045.jpg

LM Start	1.86	Rating **	A	Issue No.	19
LM End	4.45	Issue Type +	Ma	Location *	LS
Category	Earthen Levee			GPS Latitude/Longitude	
				Start	End
Item	Vegetation			39.029689 °	39.041419 °
				-121.423792 °	-121.394391 °
DWR ID	DWR_RD2103_01_s_2017_19				
Comment Code					
V1 : Control annual grass and weeds on the levee slopes and easements.					
Inspector Comment					
Annual vegetation that is well maintained, Spring 2017.

View looking downstream of annual vegetation that is well maintained, Spring 2017.

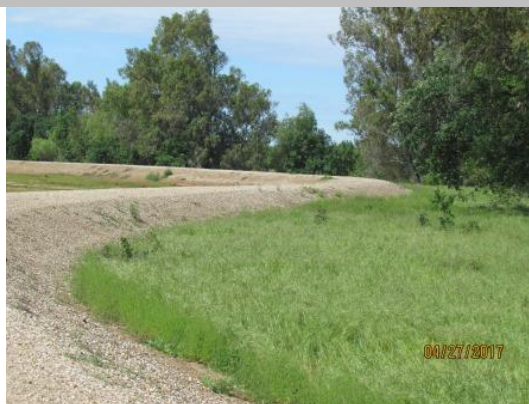
Photo 1 of 1 : SP\_2017\_RD2103\_10\_21\_20170428\_00046.jpg

LM Start	1.87	Rating **	A	Issue No.	21
LM End	4.45	Issue Type +	Ma	Location *	WS
Category	Earthen Levee			GPS Latitude/Longitude	
				Start	End
Item	Vegetation			39.029689 °	39.041414 °
				-121.423769 °	-121.394389 °
DWR ID	DWR_RD2103_01_s_2017_21				
Comment Code					
V1 : Control annual grass and weeds on the levee slopes and easements.					
Inspector Comment					
Annual vegetation that is well maintained, Spring 2017.

View looking downstream of annual vegetation that is well maintained, Spring 2017.

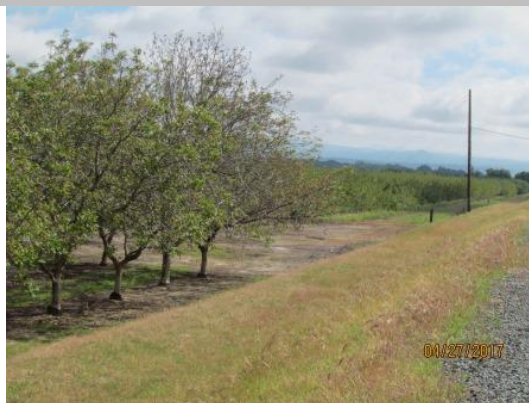
Photo 1 of 1 : SP\_2017\_RD2103\_11\_14\_20170428\_00031.jpg

LM Start	0.01	Rating **	M	Issue No.	14
LM End	2.59	Issue Type +	Ma	Location *	LS
Category	Earthen Levee			GPS Latitude/Longitude	
				Start	End
Item	Vegetation			38.993483 °	39.009338 °
				-121.437133 °	-121.397304 °
DWR ID	DWR_RD2103_02_f_2016_14				
Comment Code					
V1 : Control annual grass and weeds on the levee slopes and easements.					
Inspector Comment					
Annual vegetation needs to be maintained, Spring 2017.

View looking upstream of the annual vegetation that needs to be maintained, Spring 2017.

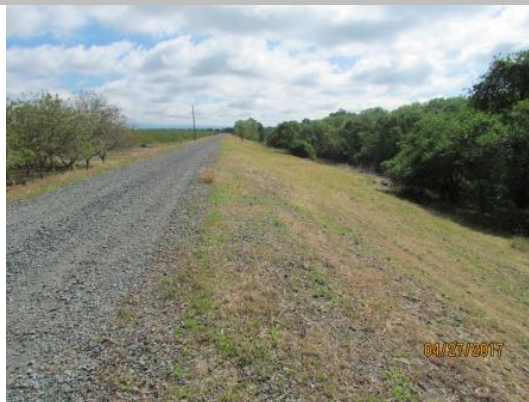
Photo 1 of 1 : SP\_2017\_RD2103\_11\_15\_20170428\_00032.jpg

LM Start	0.01	Rating **	M	Issue No.	15
LM End	2.59	Issue Type +	Ma	Location *	WS
Category	Earthen Levee			GPS Latitude/Longitude	
				Start	End
Item	Vegetation			38.993483 °	39.009339 °
				-121.437133 °	-121.397300 °
DWR ID	DWR_RD2103_02_f_2016_15				
Comment Code					
V1 : Control annual grass and weeds on the levee slopes and easements.					
Inspector Comment					
Annual vegetation needs to be maintained, Spring 2017.

View looking upstream of the annual vegetation that needs to be maintained, Spring 2017.

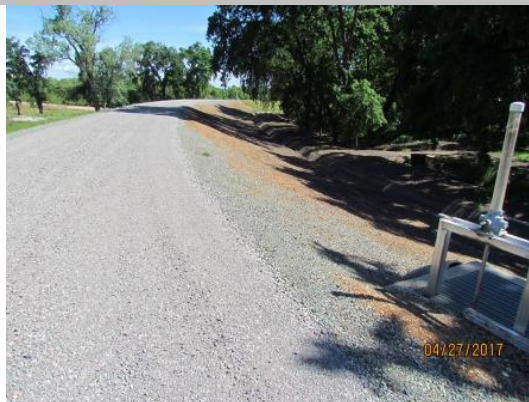
Photo 1 of 1 : SP\_2017\_RD2103\_11\_13\_20170428\_00033.jpg

LM Start	2.59	Rating **	A	Issue No.	13
LM End	2.67	Issue Type +	Ma	Location *	WS
Category	Earthen Levee			GPS Latitude/Longitude	
				Start	End
Item	Vegetation			39.009335 °	39.010327 °
				-121.397305 °	-121.396597 °
DWR ID	DWR_RD2103_02_s_2017_13				
Comment Code					
V1 : Control annual grass and weeds on the levee slopes and easements.					
Inspector Comment					
Well maintained annual vegetation, Spring 2017.

View looking upstream of the annual vegetation that is well maintained, Spring 2017.

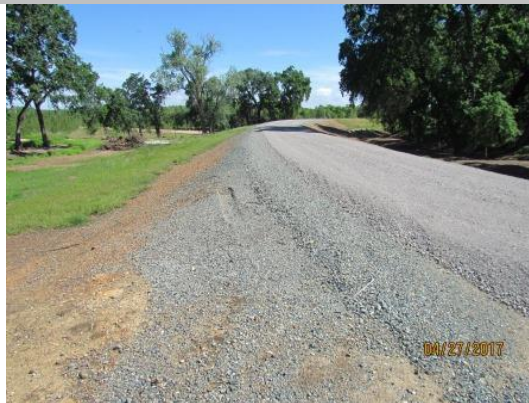
Photo 1 of 1 : SP\_2017\_RD2103\_11\_12\_20170428\_00034.jpg

LM Start	2.60	Rating **	A	Issue No.	12
LM End	2.67	Issue Type +	Ma	Location *	LS
Category	Earthen Levee			GPS Latitude/Longitude	
				Start	End
Item	Vegetation			39.009348 °	39.010327 °
				-121.397312 °	-121.396597 °
DWR ID	DWR_RD2103_02_s_2017_12				
Comment Code					
V1 : Control annual grass and weeds on the levee slopes and easements.					
Inspector Comment					
Well maintained annual vegetation, Spring 2017.

View looking upstream of the annual vegetation that is well maintained, Spring 2017.
